MARSH'S LIBRARY

CONSERVATION MANAGEMENT PLAN

MAY 2024

7L
ARCHITECTS

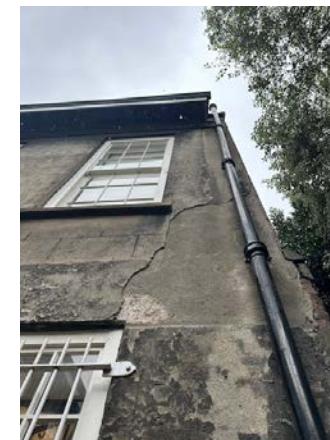
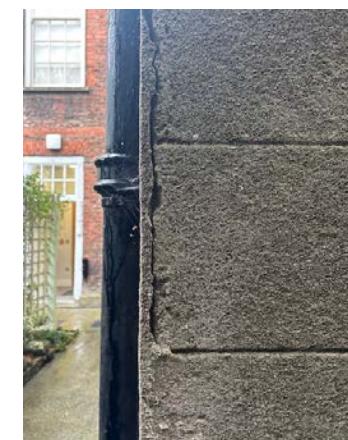
27 & 28. Views of cracked ruled ashlar render to east range.

coursed stone wall. There are signs of patch repairs to the render on the south-facing gable, applied crudely at the verges, most likely when it was re-roofed in the 1960s, and these are a possible source of water ingress. The render is cracking very badly, in some areas it has already delaminated from the wall. The east and north facades have smooth hard cement render, which is also cracked.

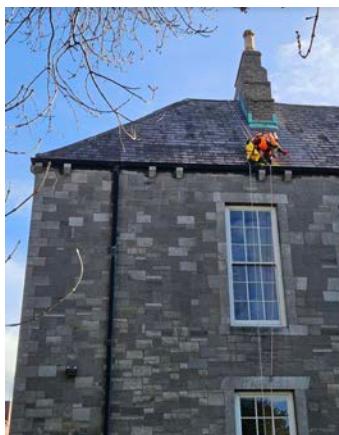
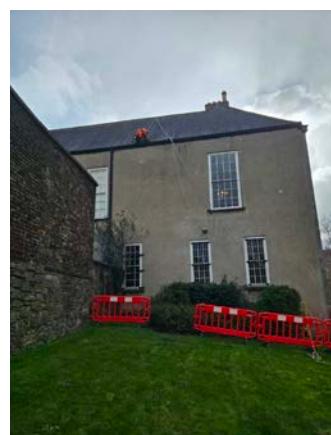
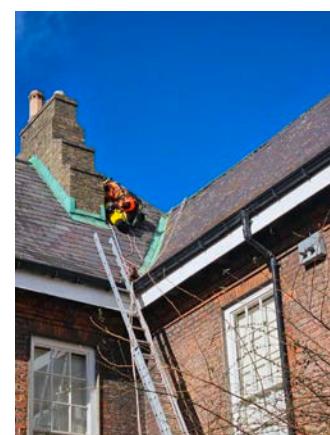
are numerous copper tingle repairs mainly along the eave gutters where slates have slipped in the past. Slippage along the slopes may indicate some corrosion of fixings which will need to be monitored in anticipation of a further programme of roof works in the future.

35-37. Niall McDonagh undertaking recent roof inspection, cleaning and repairs using safe rope access method where installation of scaffolding or hoist hire would be needed.

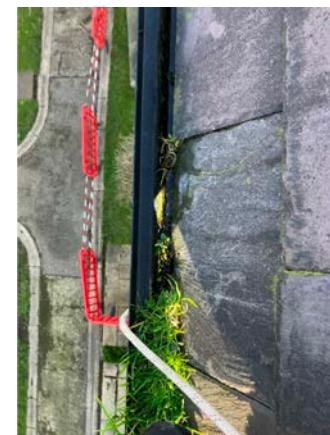
38. Detail of blocked gutter.

On the stone western façade, the gutters are supported off paired limestone corbels. These carry along the brick facades of the south range. Along the garden facades, white painted fascia boards have been fitted on timber brackets sitting on brick corbels. It is an incongruous detail that would be unnecessary if a new replacement gutter of larger capacity was installed with brackets fixed directly onto the existing timbers. Insect mesh fitted under the eaves would prevent easy access for vermin such as nesting birds. Ground drains were not tested and should be cleared and surveyed using CCTV to identify any blockages or build up.

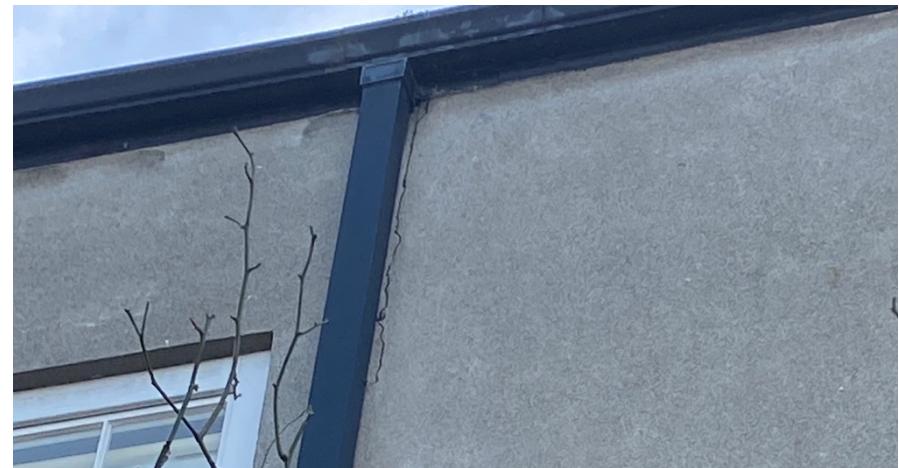
40. Detail showing cracked render under downpipe to north wall.

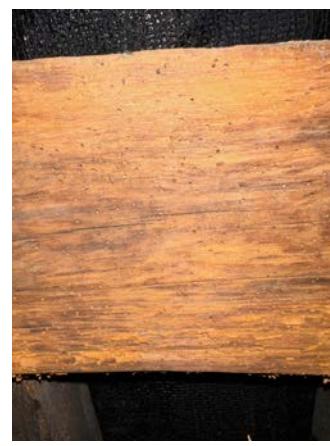
A light trap has been placed in the west range to prevent beetle attack. Damp specialists who recommended this installation over the years as they made inspections are unconcerned about beetle attack as the roofspace has dried out sufficiently. The trap should continue to be monitored in case of re-occurrence. Frass left by previous infestations should be removed so that this could also be used to determine whether beetles have returned.

45. Beetle damage & frass (historic).

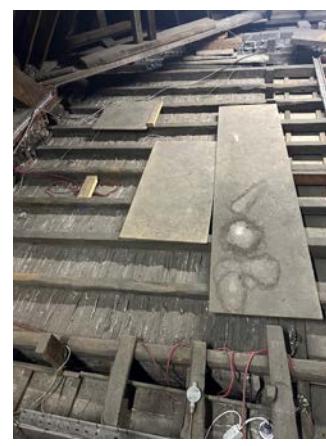
46. Evidence of drip in south range.

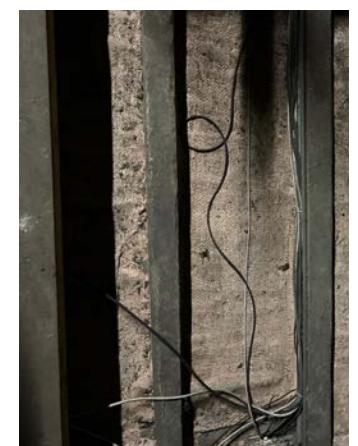
48. Gypsum treated hessian over reading room for fire proofing.

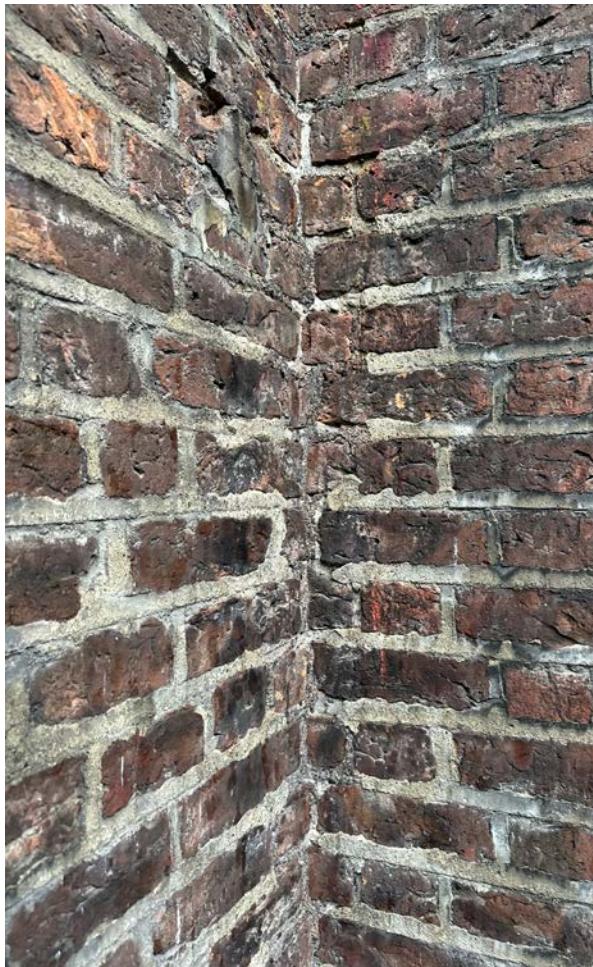
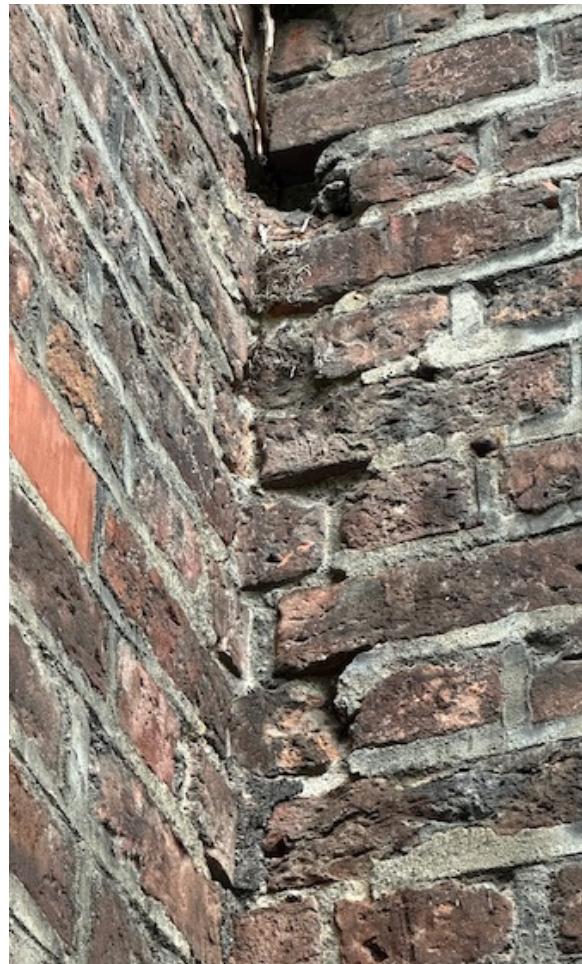
Original brick facings have largely been re-pointed using a hard cement-mortar. While most of the bricks are rough and hand-made using local clay; rubbed bricks used as voussoirs to the flat arch window heads were imported from England. Bricks are generally laid using a Flemish-bond, with some variation in the distribution of headers and stretchers between the courses, to cope with uneven brick sizes around the window openings.

49 & 50. Views of hard cement pointing and missing joints and bricks to corners.

In places where the hard cement mortar has fallen away, the original lime bedding can be seen behind. Spalling of the brick faces can be found in all areas, along with sulphate crusts that pre-date the cement re-pointing. Frost and atmospheric pollution have left the faces of the brick friable in places and will be especially vulnerable to mechanical damage when the hard cement-rich mortar is eventually removed. Cement-rich mortars can cause serious damage by trapping water in the bed joints and accelerating decay of the brick. This is a significant risk to the conservation of the book collection and the stalls, being susceptible to raised humidity levels leading to mould growth internally.

In 2015, a sample of damaged brickwork under a ground floor window under repair was repointed using softer lime mortars, which suggested that ruled flush jointing would be the most appropriate treatment for the brickwork when the cement mortar is removed. While hard, the cement was removed by hand using a chisel without resort to cutting, and the friable surface of the brick was unaffected by the operation. Bedding mortar was used as a match for the new lime re-pointing, using small pebbles and crushed brick of appropriate size, finished flush to the wide joints.

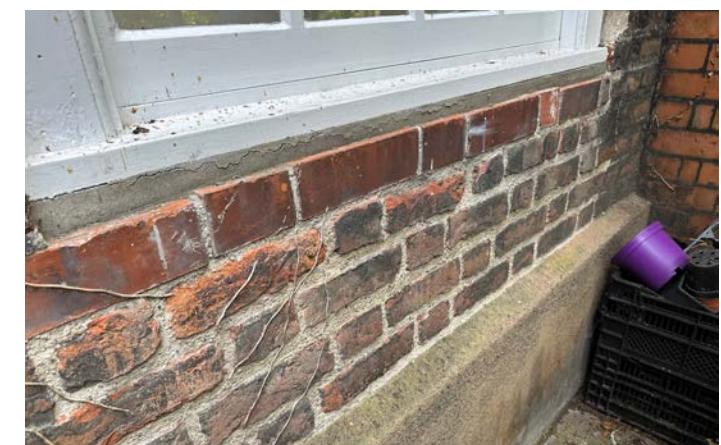
53. Detail of 2015 test repointing using lime mortar.

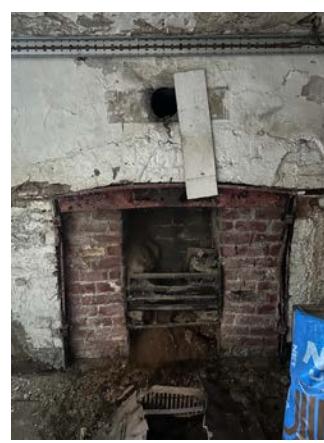
The basement is currently in a poor state of repair and is unfit for habitation or storage. It is accessed from a steeply pitched staircase leading from a door in the entrance hall of the former apartment. There are four rooms; two located beside the stairs are formed by timber stud walls with lath and plaster linings that are in poor condition. The room to the east side is a dark cellar with a timber post propping the floor joists above and the ceiling is lined with fire-rated plasterboard. Opposite is a slightly larger room with a window overlooking the graveyard, it has recently been fitted with timber propping to the sagging floor joists above. The ceiling in this room has retained some lath and plaster, but large sections have also been lined with fire-rated plasterboard.

69. Detail of damp and rot.

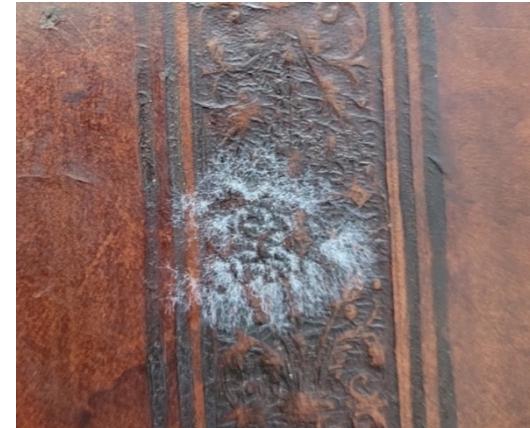
111. Detail of mould damage to book cover.
