MARSH'S LIBRARY

CONSERVATION MANAGEMENT PLAN

MAY 2024

7L
ARCHITECTS

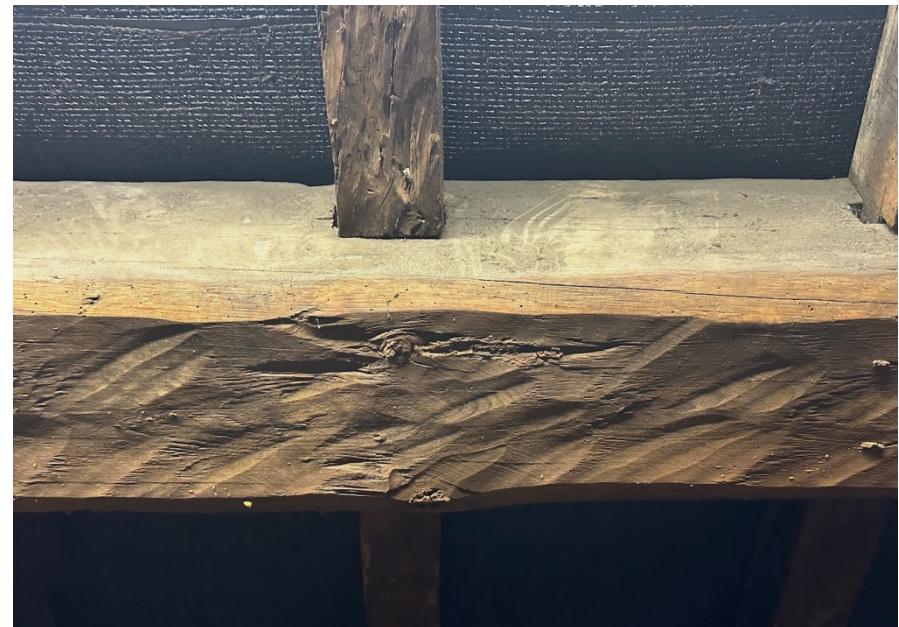
The main roof timbers include much that has survived from the original roof construction in the early eighteenth century, and some assembly marks are visible cut into the side of the joists. The present slate covering probably dates to the 1960s, when a comprehensive re-covering was undertaken under McDonnell Dixon Architects, by using salvaged slates. These range from blue, grey and red in colour, perhaps reflecting the many different phases. Slopes are capped with clay ridge tiles, some of which have experienced mortar loss. Outer sloping ridges are also capped with clay tiles, whereas the internal slopes are fitted with copper, with a bright verdigris suggesting that they might date to the nineteenth century.

30. Detail of original roof timbers showing adze marks & modern felt.

In the roofspace, the extensive use of breeze felt, a non-permeable bituminous membrane can be seen, in common use in the twentieth century. Short gauge slates (24 x 14 inches) known as Princesses have been used that better cope with the uneven slope. Thicker and longer slates are found behind the west range chimney, possibly undisturbed since the 1860s when this stack was altered. On the other side of the ridge, a green/grey slate is used (possibly from Westmoreland in Cumbria) with some replacement Blue Bangors which might also be the longest surviving slates. A distinctive detail is the bell cast at the eaves. This has been retrofitted with timber sprockets placed on top of the rafters to throw the rainwater off the slope more efficiently.

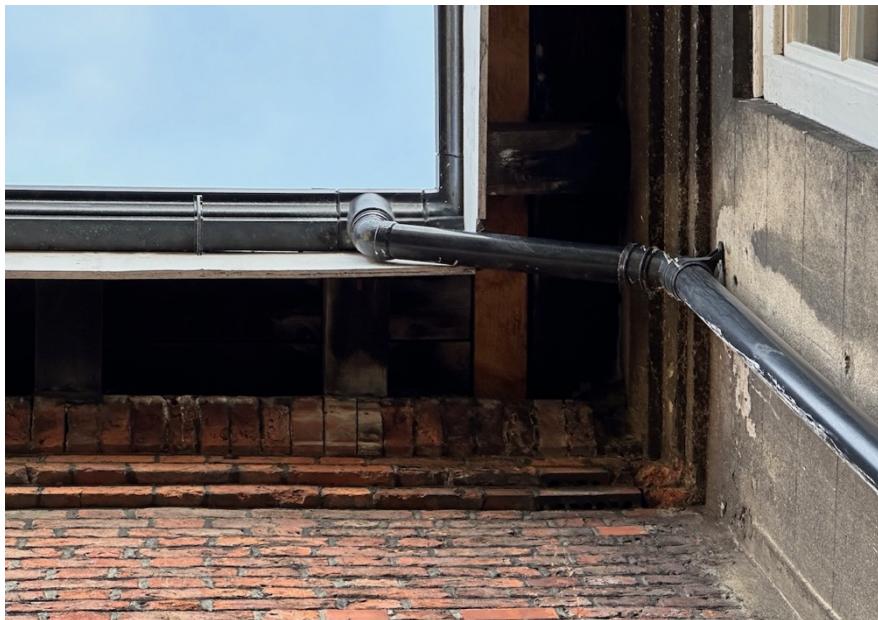
Where slates have cracked, some have been repaired with mastic, which will fail in time so is not recommended. Below the eaves course, a sheet metal undercloak has been installed that is dressed into the gutter and which increases the risk of blocking. Both smaller roofs to the entrance lobbies are covered with slates and capped with clay ridges.

31. Detail of modern eaves board and guttering to garden facades.

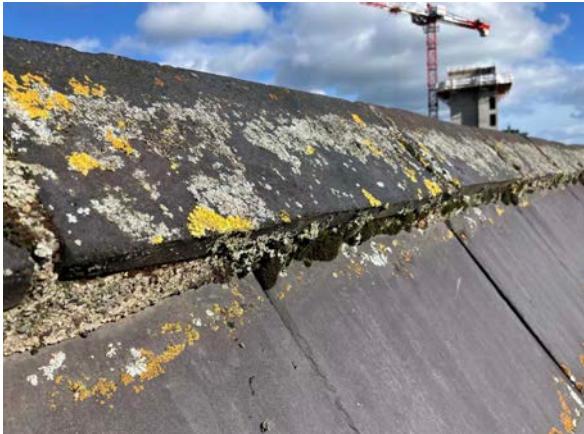
32. View along ridge showing pointing intact.

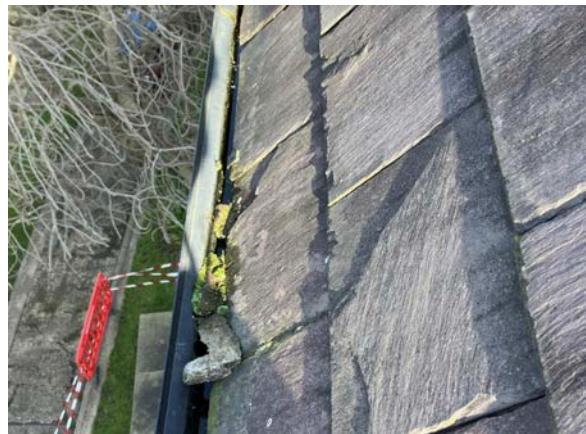
33. View of blocked gutter along west wall.

dampness evident in the Old Reading Room is due to this external gutter blocking up with vegetation despite regular cleaning - twice already in 2024. Persistent blockages are causing rainwater to seep into the wall during incidents of heavy rain, where it is sealed by the cement render and makes its way slowly down the wall below. Some sections are difficult to access safely, and the use of rope access by specialist roofing teams might be cost effective when compared with the hire of hoists or scaffolding.

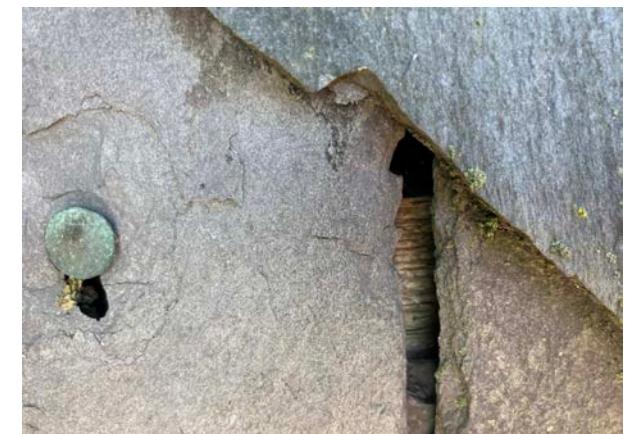
Slate courses are uneven, due to differential settlement of the roof structure, causing some slates to sit up slightly making them more susceptible to driving rain. Slates inspected during repair works show that they have been holed more than once, and copper nails appear to have been used in the 1960s, where some corners were chamfered to re-condition the untidy edges of the otherwise sound slates for salvage. There

34. Detail of slipped slate showing gap for water ingress.

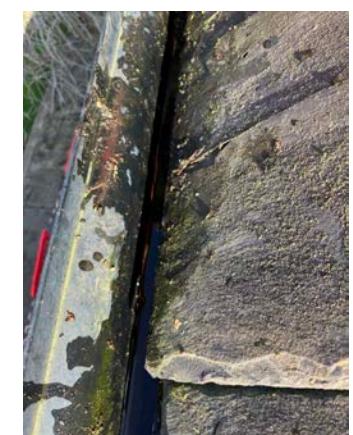
39. Gutter following cleaning.

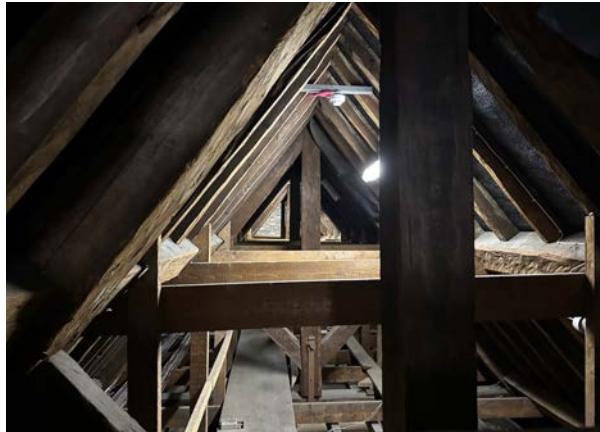
In the west range, the raised tie-beam king post trusses with wrought iron stirrups need to be carefully negotiated. Simpler tie-beam trusses are found to the north and east ranges. Vertical metal tie rods and gusset plates have been installed at the apex to a number of these trusses, along with additional framing. Evidence for alterations is found above the main staircase where a similar tie-beam as above the old reading room is found.

41. View along west range attic with king post trusses.

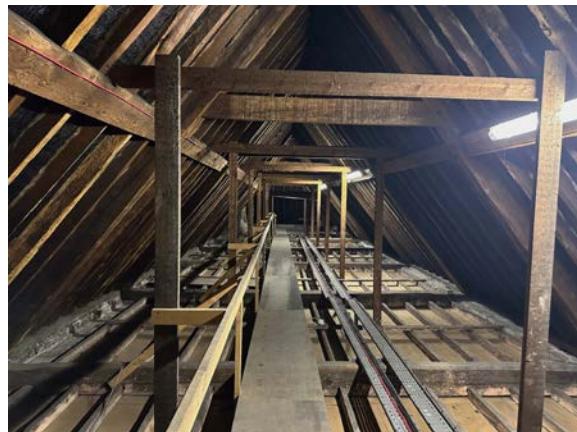
42. View along north range attic with queen post.

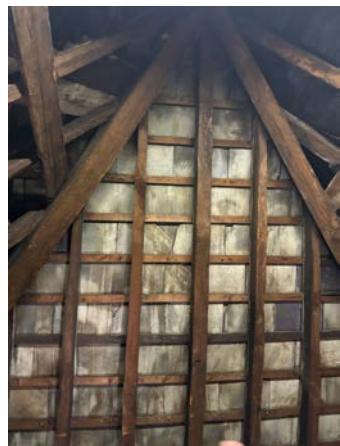
44. Unfelted slating to south range.

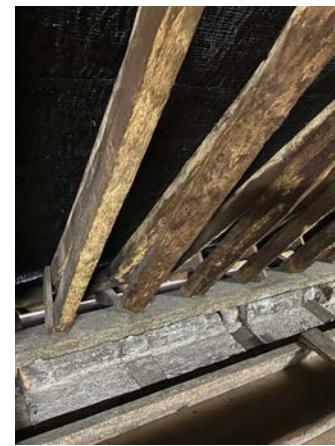
47. Unwrought timber without birdsmouth detail in roofspace.

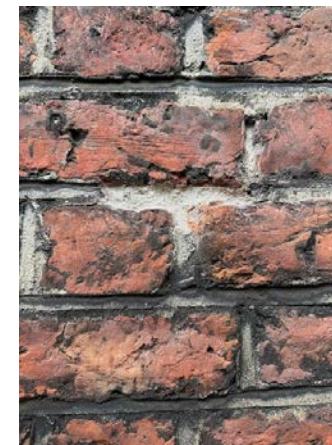
52. Ruled joint detail.

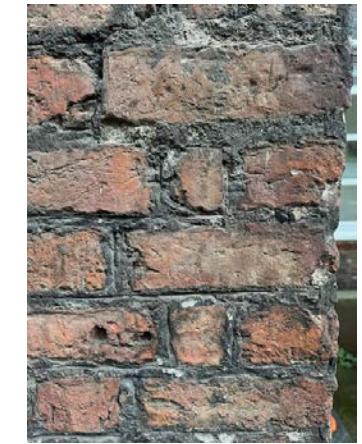
53. Detail of 2015 test repointing using lime mortar.

In 2015, a sample of damaged brickwork under a ground floor window under repair was repointed using softer lime mortars, which suggested that ruled flush jointing would be the most appropriate treatment for the brickwork when the cement mortar is removed. While hard, the cement was removed by hand using a chisel without resort to cutting, and the friable surface of the brick was unaffected by the operation. Bedding mortar was used as a match for the new lime re-pointing, using small pebbles and crushed brick of appropriate size, finished flush to the wide joints.

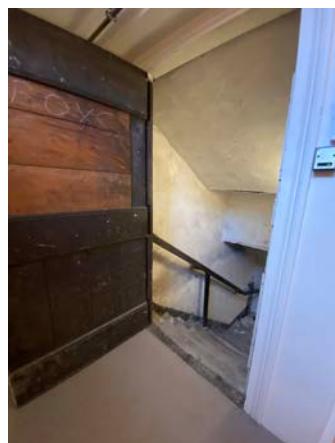
68. Entrance door to basement.

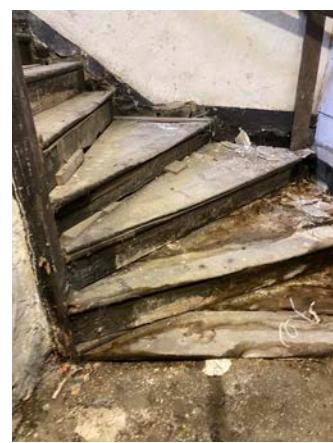
69. Detail of damp and rot.

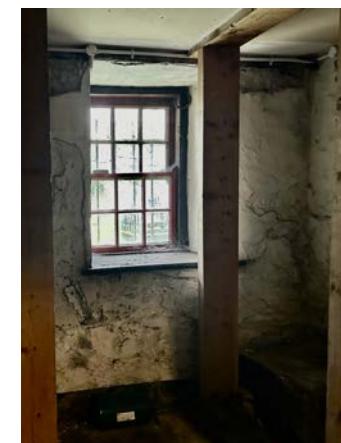
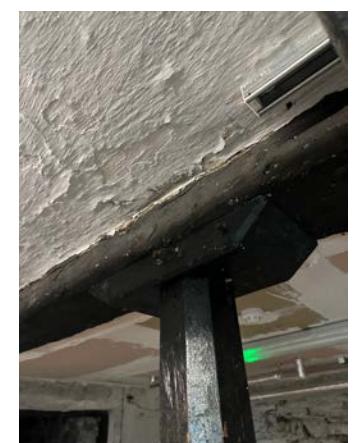
71-72. Views of window & recent & historic propping in basement.

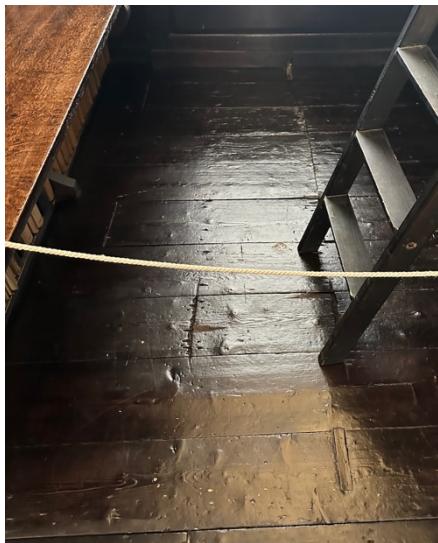
86. Floorboards showing marks of original benches removed in 18c.

evidence of having been lifted many times previously, more noticeable in the First Gallery. In the second gallery the runner is slightly wider and is tucked under the base of the shelving. A runner has also been installed to the main staircase, which had been slippy in wet weather. A non-slip safety floor has been used in the WC in the former Room Z.

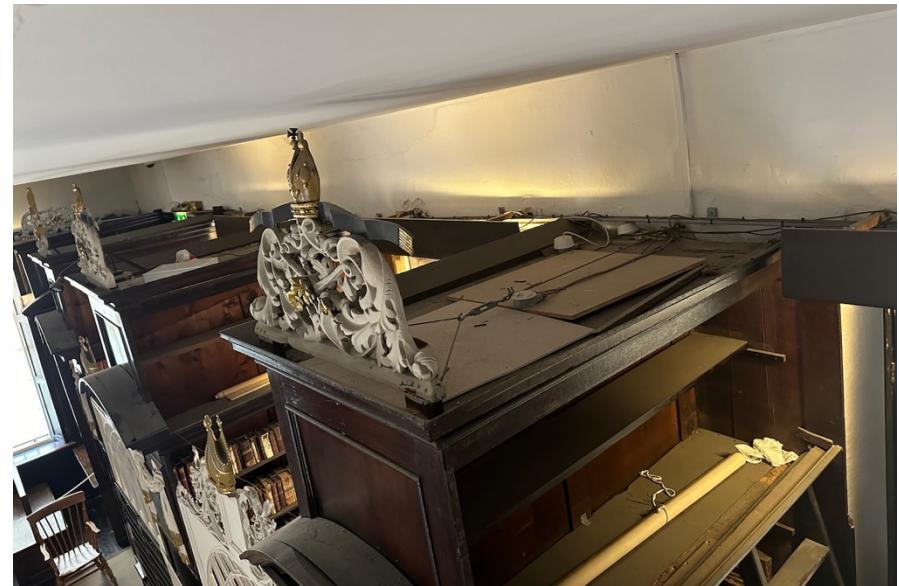
Conservation Letterfrack undertook remedial work to bookstall G1.2. The thin oak shelves are also sagging extensively, and this can be remedied by adjusting and supplementing the slender fins.

97. View of bookstalls in Second Gallery from above.

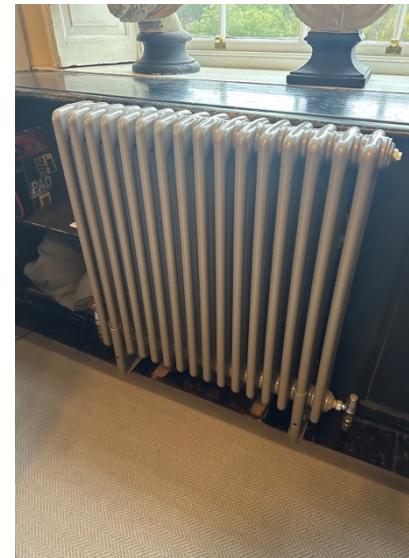
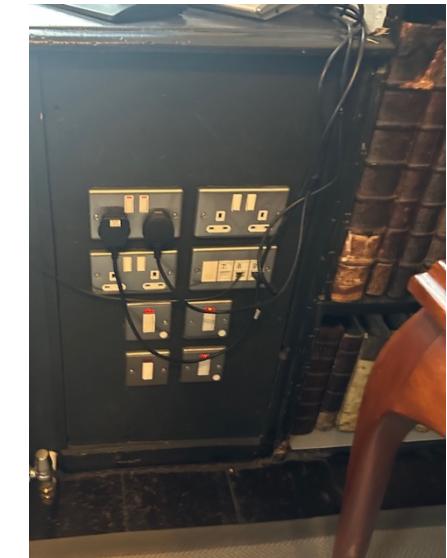
Space heating is provided to water-filled radiators fired by a gas heating system in the Old Reading Room at first floor level and in the offices and reading room downstairs. Staff members wrap up against the cold in the winter months. While monitoring had been installed along the bookstalls, there remains a risk of elevated moisture levels in the galleries, especially due to the increased visitor numbers. The Seminar Room / shop is heated using an air conditioning unit installed within the new suspended ceiling.

99 & 100. New electric heater and installation in Old Reading Room.

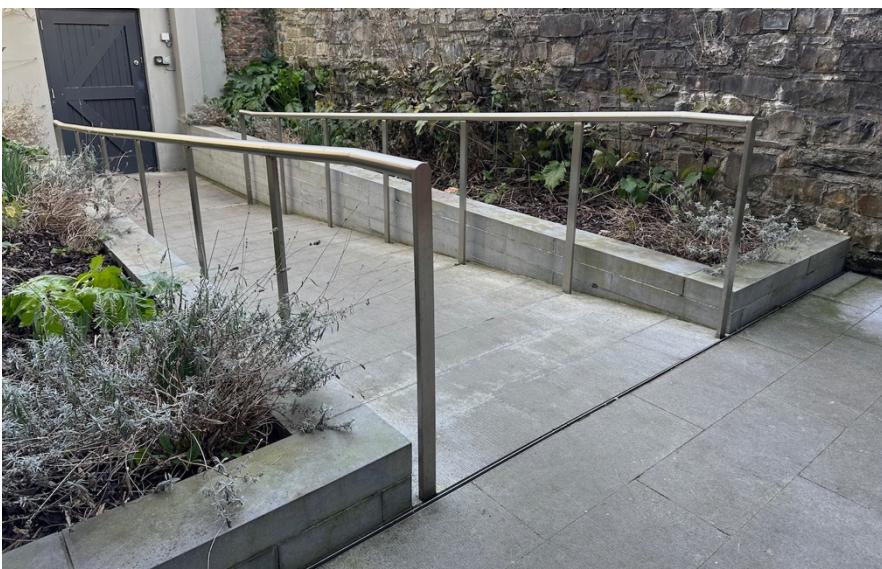
While access to the library for wheelchair users remains restricted, several initiatives have been taken in recent years. To access the galleries, visitors cannot avoid using steps from any approach. A limestone ramp has been installed to the external gate from the lane off Bride Street, which gives access as far as the garden, where the steps up to the rooms to the ground floor level need to be negotiated. In Room Z, a new WC has been installed, but this level cannot be reached by wheelchair users. An accessible toilet is available at ground floor level adjacent to the Seminar Room.

101. View of new accessible ramp to East Yard.

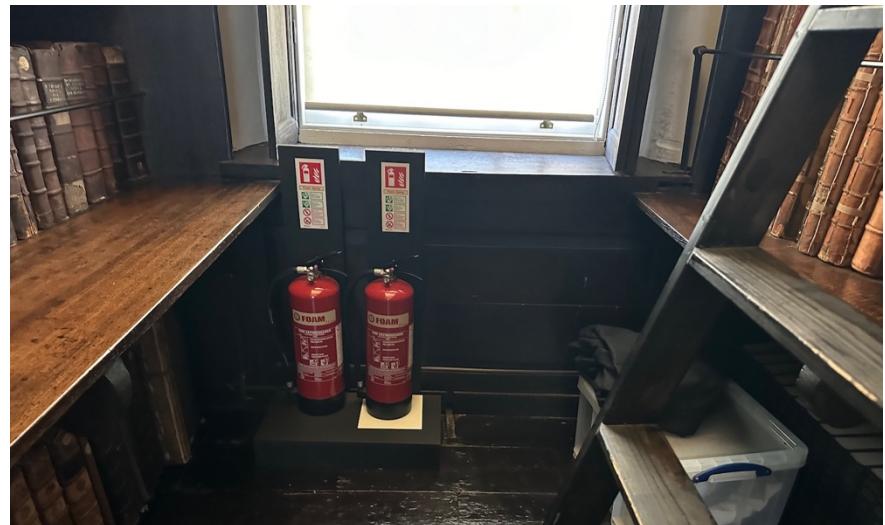
102. Fire extinguishers in First Gallery.

Placed around the building are fire extinguishers, break glass units, fire alarm detector heads and sounders. These continue to be maintained, and

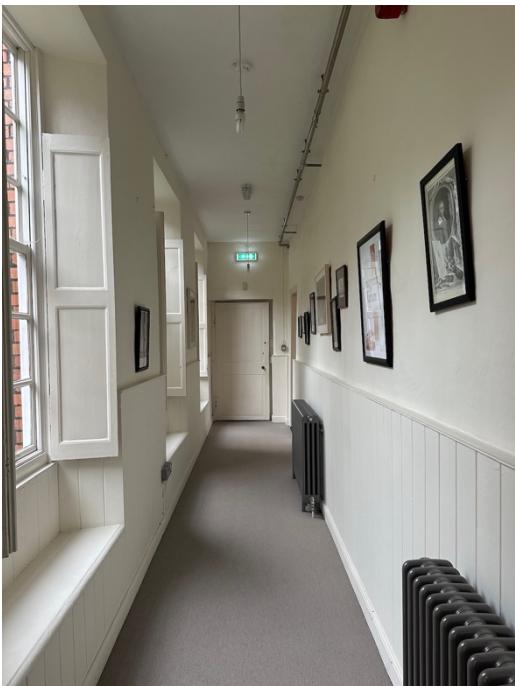
A ceiling mounted mist fire suppression system has been installed on the ground floor. Gas-based suppression for the galleries is under consideration but not yet advanced. The hot and cold water and waste disposal services from the kitchens and toilet areas in the library are of recent date and appear to be functioning adequately, however, the bathroom and kitchen of the keeper's apartment needs to be upgraded.

103. Mist suppression to corridor.

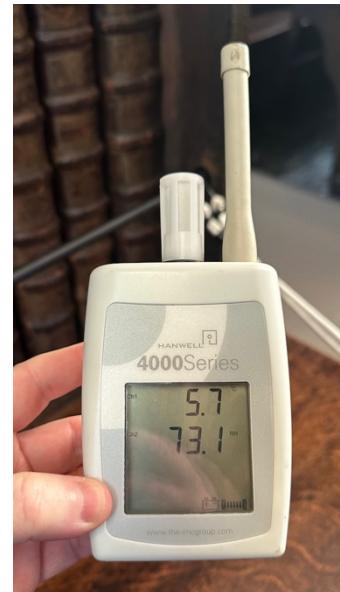
109. Monitor reading.

While it is appreciated that the library has worked well over three centuries in preserving its collection, it is important to acknowledge that climate change and increased visitor numbers will bring new challenges. At present, there are no environmental controls in the library. Monitors placed on the bookstalls confirm that the interior temperature and relative humidity are susceptible to external conditions throughout the seasons, dipping below acceptable levels in the winter months. Therefore the increased risk of mould growth, unacceptable in a library, arises short-term weather fluctuations, longer-term climate change, and an increased number of visitors to the library.

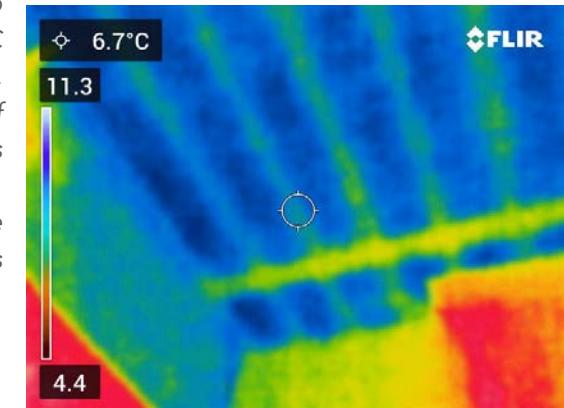
110. Extract from thermal imaging camera showing heat loss through uninsulated roofspace.

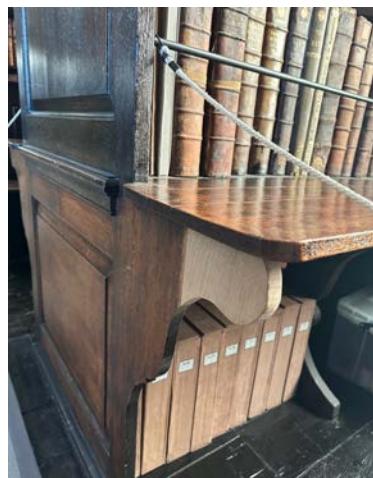
112. Detail of ongoing repairs to bookstalls.

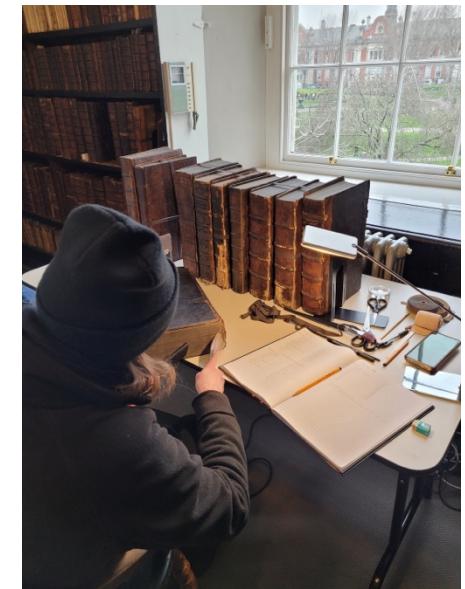
Sporadic moisture ingress into the library walls is of most immediate concern, leading to localised mould growth on books. Improved maintenance of the roofs and the removal of hard cement from the walls are a priority. Careful sequencing of urgent specialist repair works will be required to ensure that the risks to the preservation of the historic books, finishes and joinery is addressed.

114. Cleaning mould from books.
